**JOHN F. KENNEDY
SPACE CENTER**

MAB 431-68

(Interim Report)

**CORROSION STUDY OF BARE AND COATED
STAINLESS STEEL**

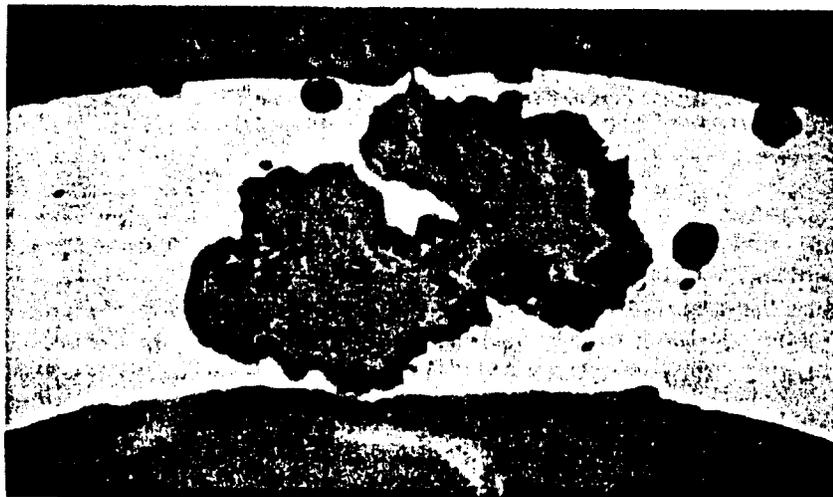
Figure 1. Perforation of Stainless Steel Tubing Used in High-Pressure Oxygen System on Astronauts' Transfer Van

Figure 1 shows an enlarged view of the surface of a 3/8-inch diameter tube with the perforation indicated by an arrow (View A). A cross-section through the tubing wall in the perforation area is also shown (View B) enlarged to 50X. This failure occurred in a high-pressure line on the Astronauts' Transfer Van.

Perforation on tube surface indicated

Cross-section through perforation in tubing wall

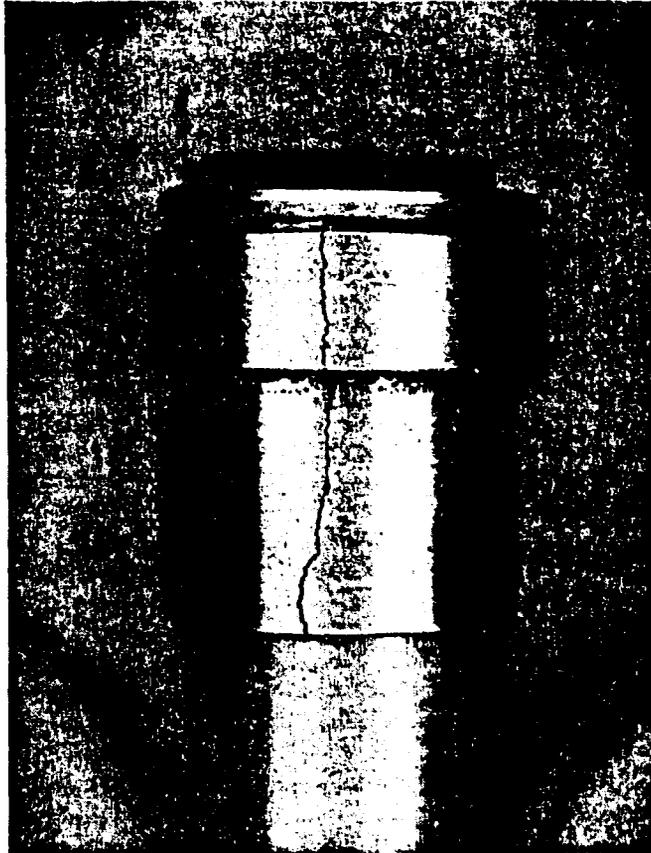
Figure 3. Cracked B-Nut Sleeve From Control Console Line,
Mobile Launcher Service Arm 8, Complex 39

Figure 3 illustrates a typical example of stress-corrosion failure. The sample shown is a stainless steel B-nut sleeve containing a longitudinal crack extending the full length of the sleeve. This sample had been removed from a console line used on a mobile-launcher service arm.

Sleeve full-length stress corrosion crack

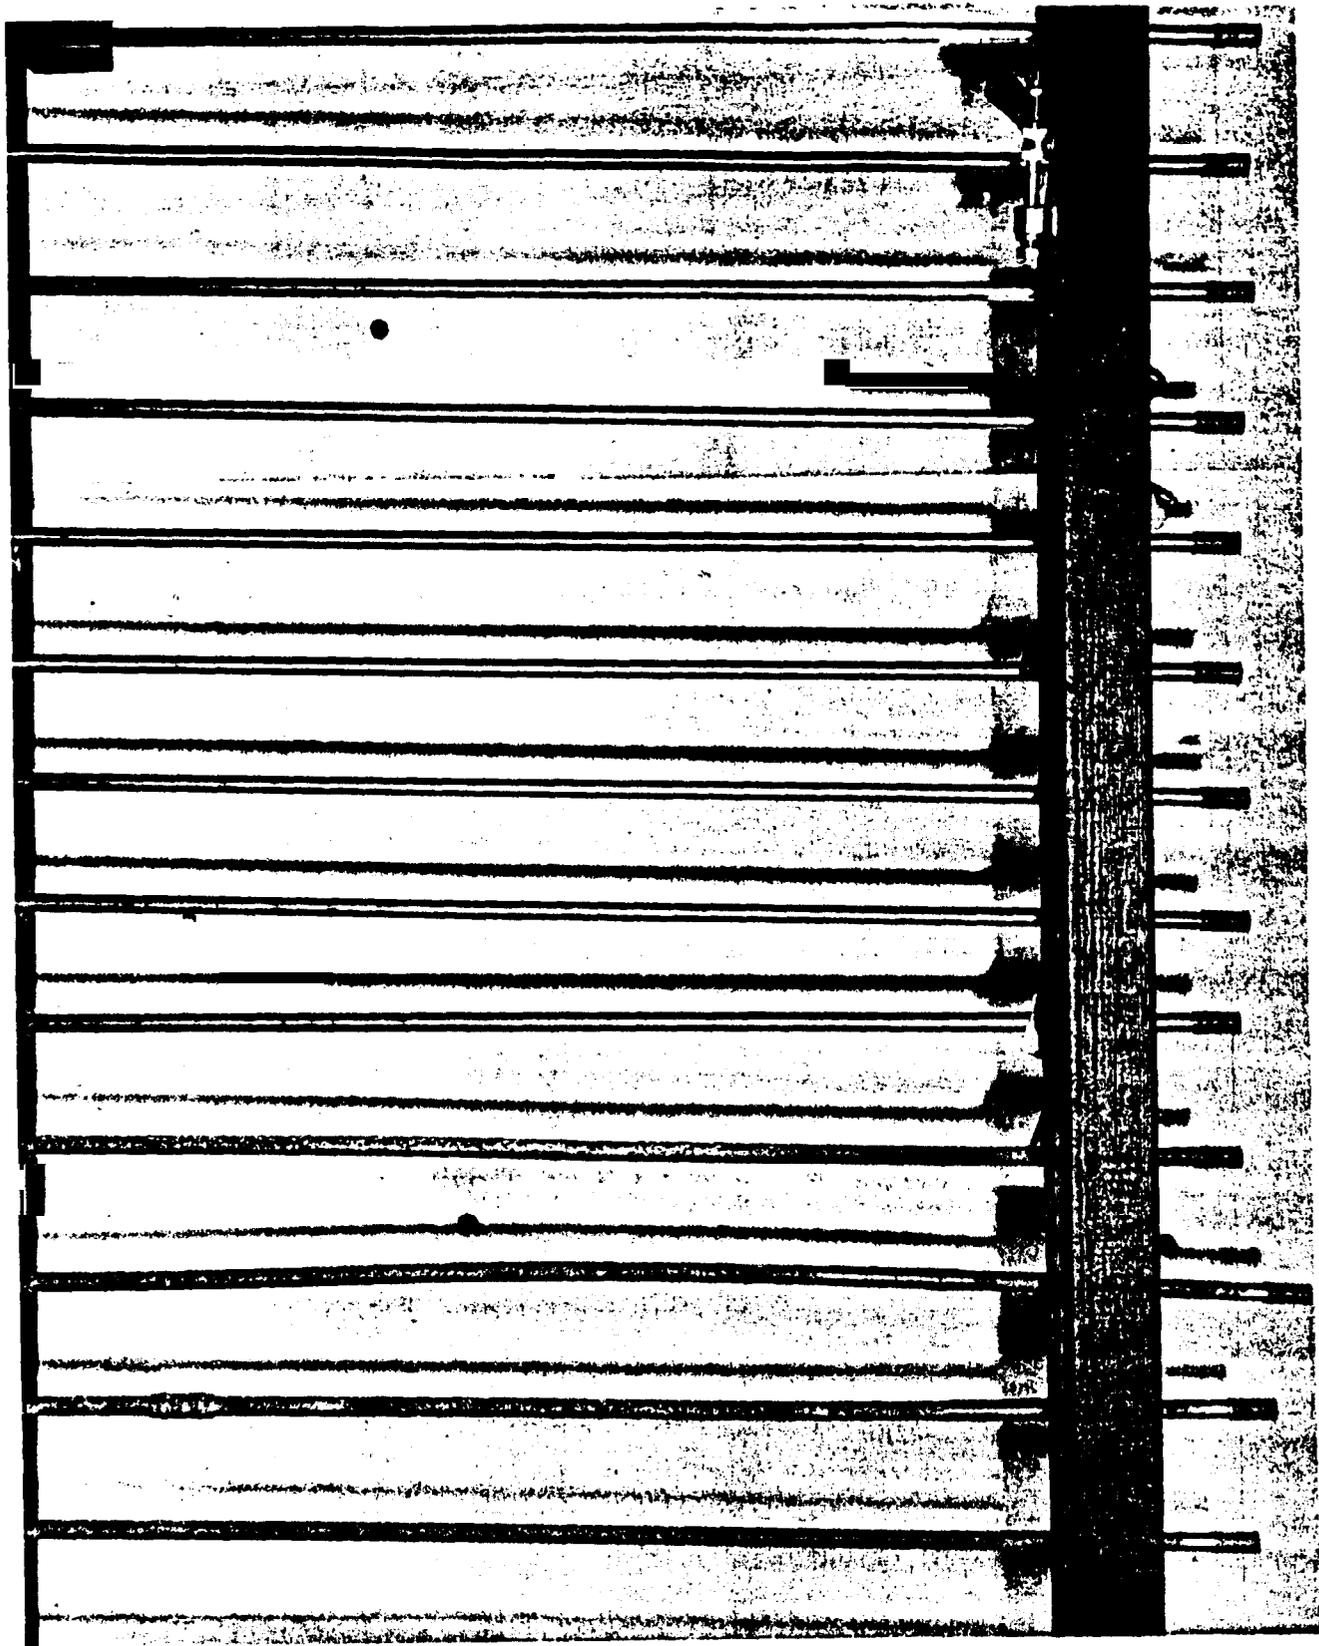
Figure 5. Tubing Samples in Sheltered Section of Rack Number 3 After 3-Months Exposure (The Four Organic-Zinc Coated Samples are Shown at Bottom>

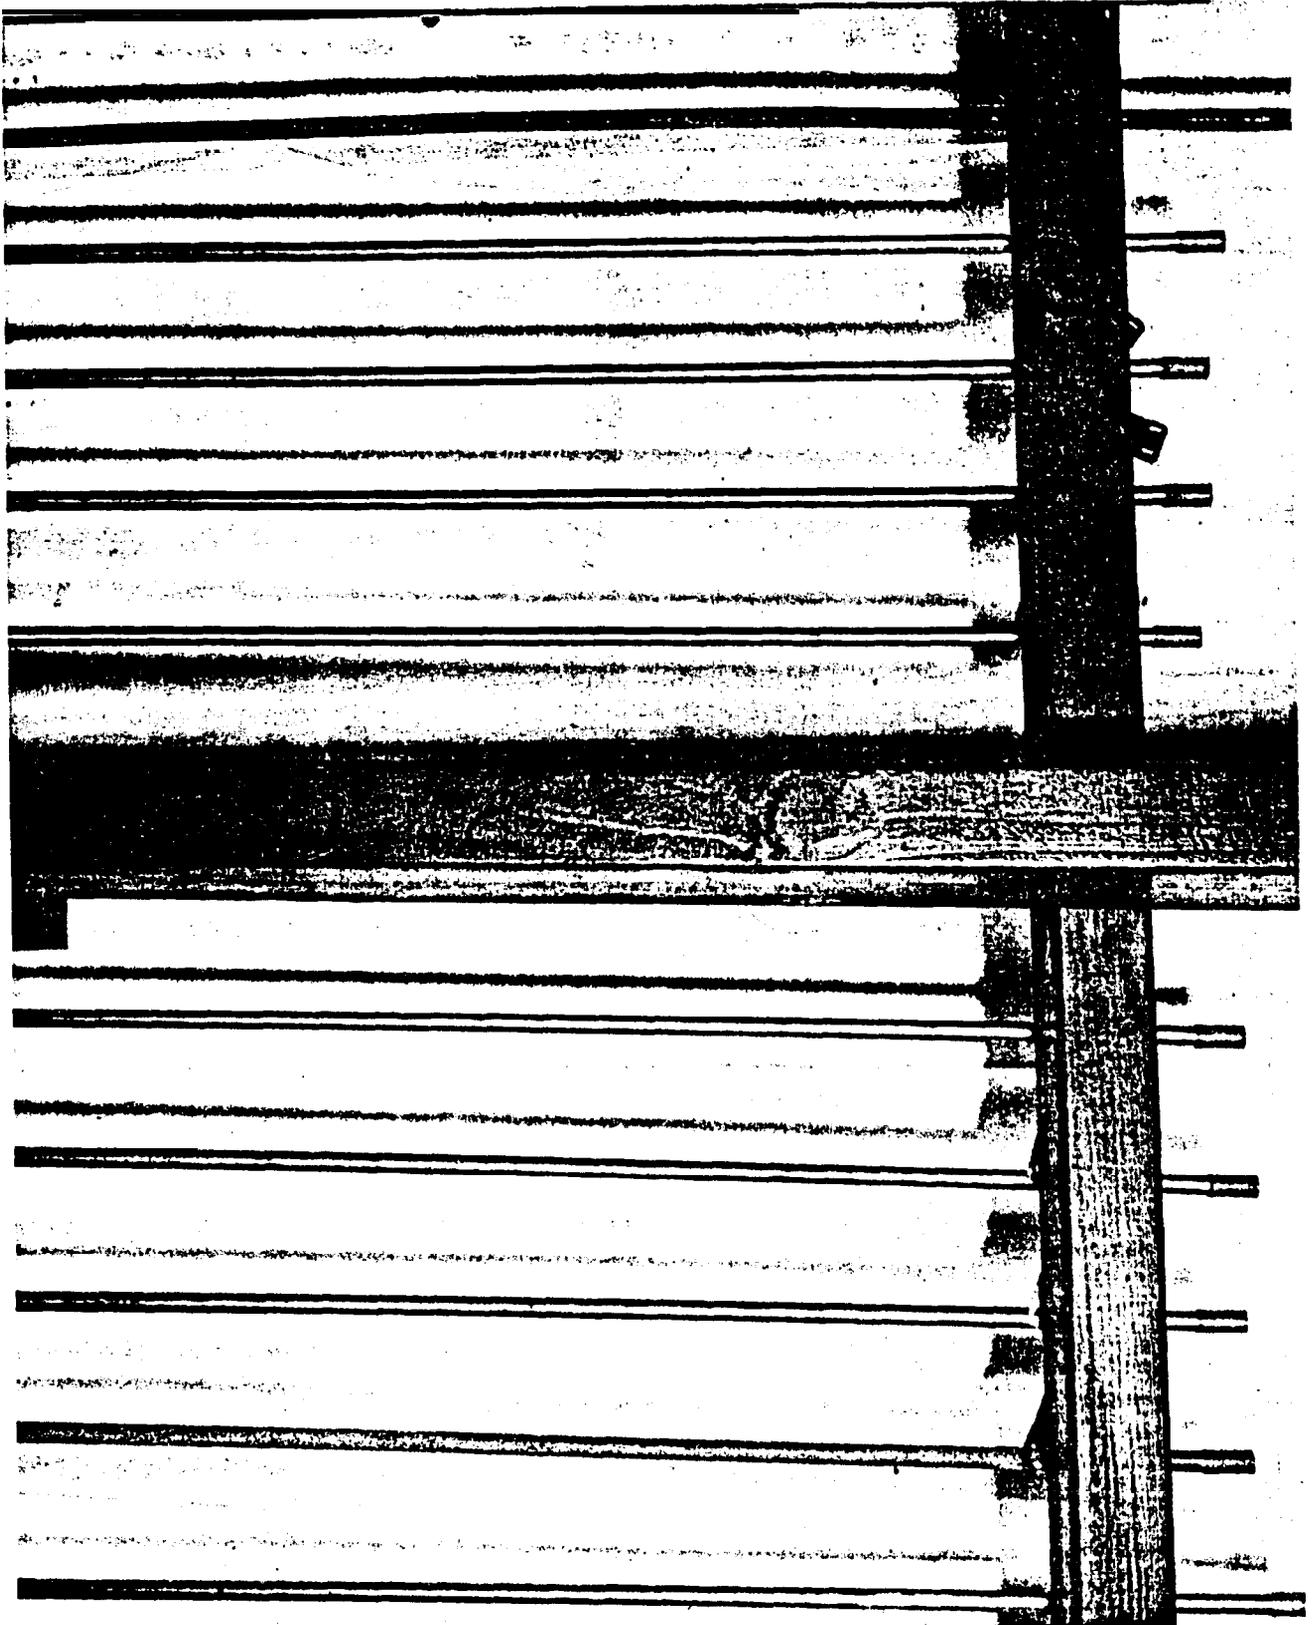
Similar conditions are shown on the bare samples illustrated in Figure 6. The single coated sample at the bottom of the photograph has the inorganic zinc paint applied over a sandblasted surface. This coating has remained intact after 30 months exposure.

Figure 6. Tubing Samples in Sheltered Section of Rack Number 3 After 3-Months Exposure (The Inorganic-Zinc Coated Sample is Shown at Bottom)

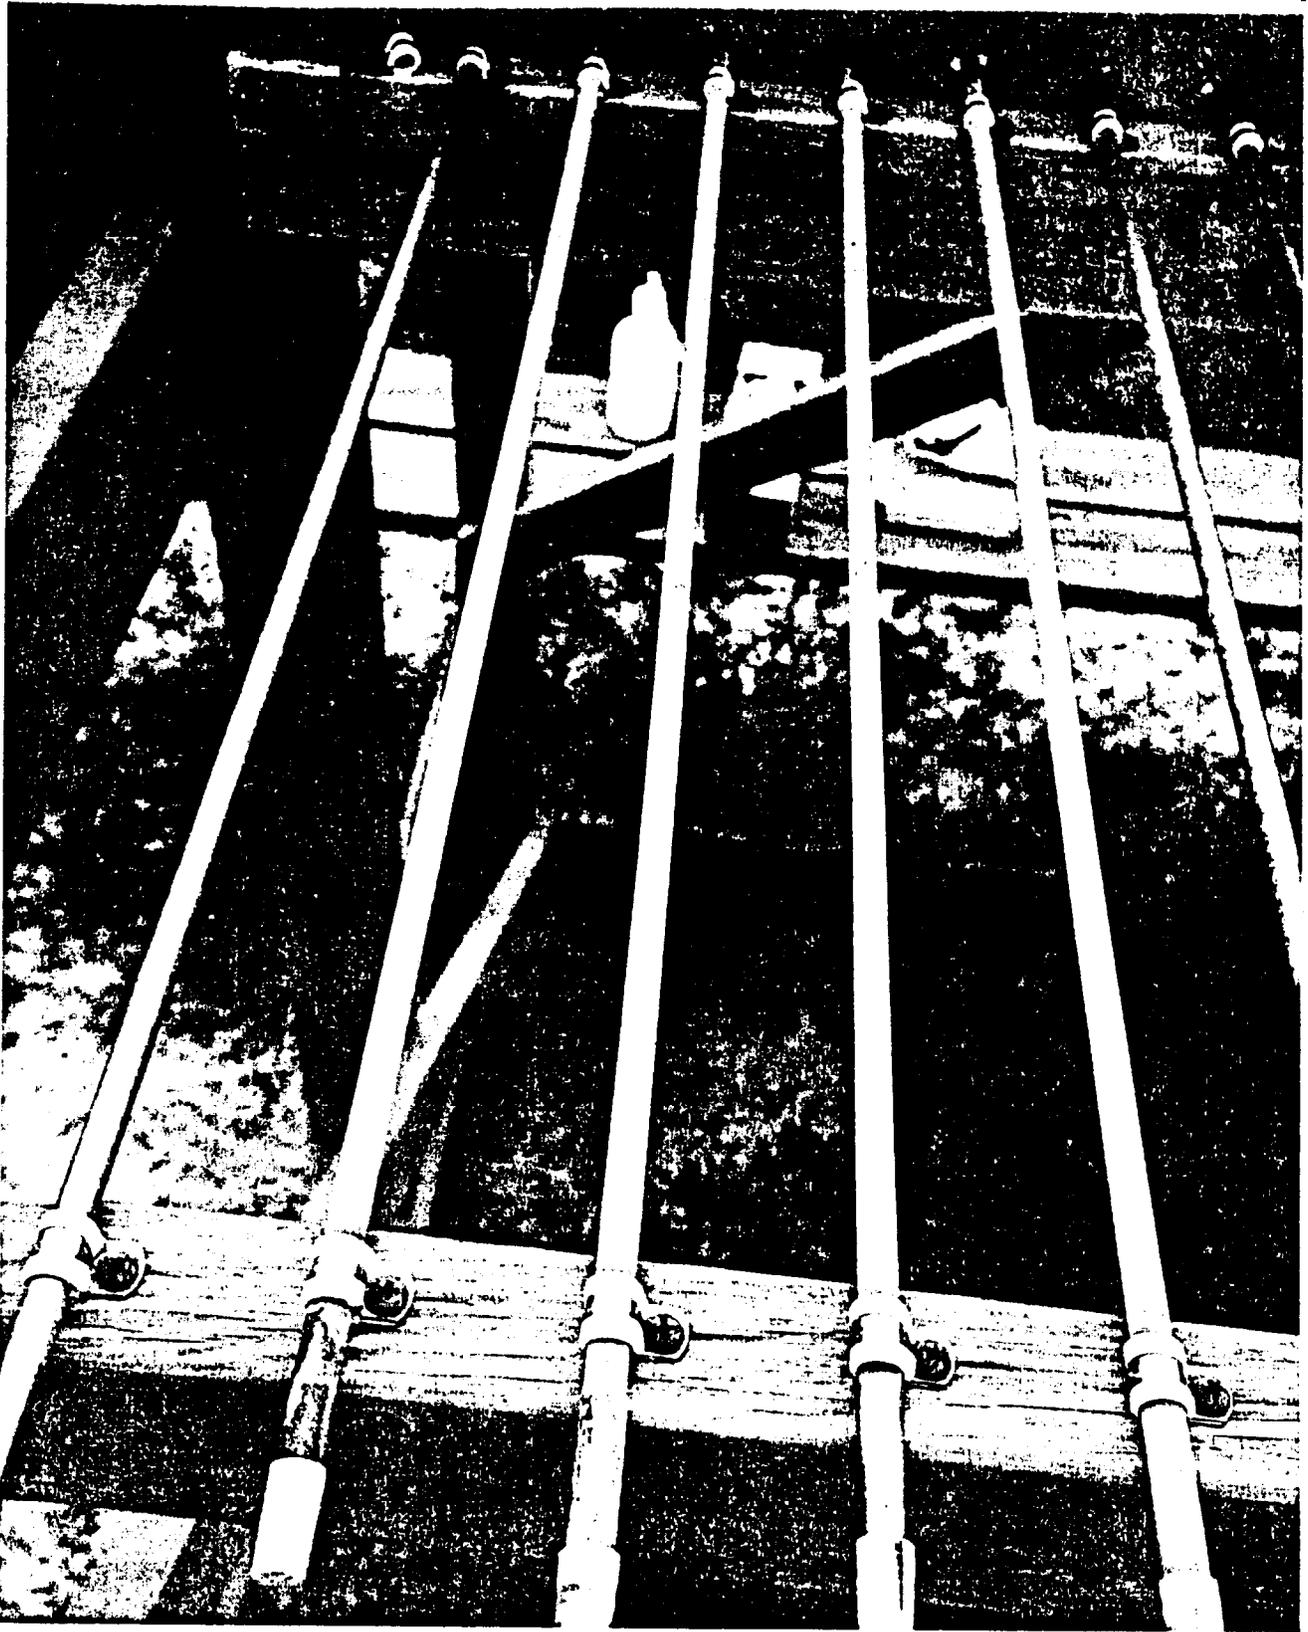
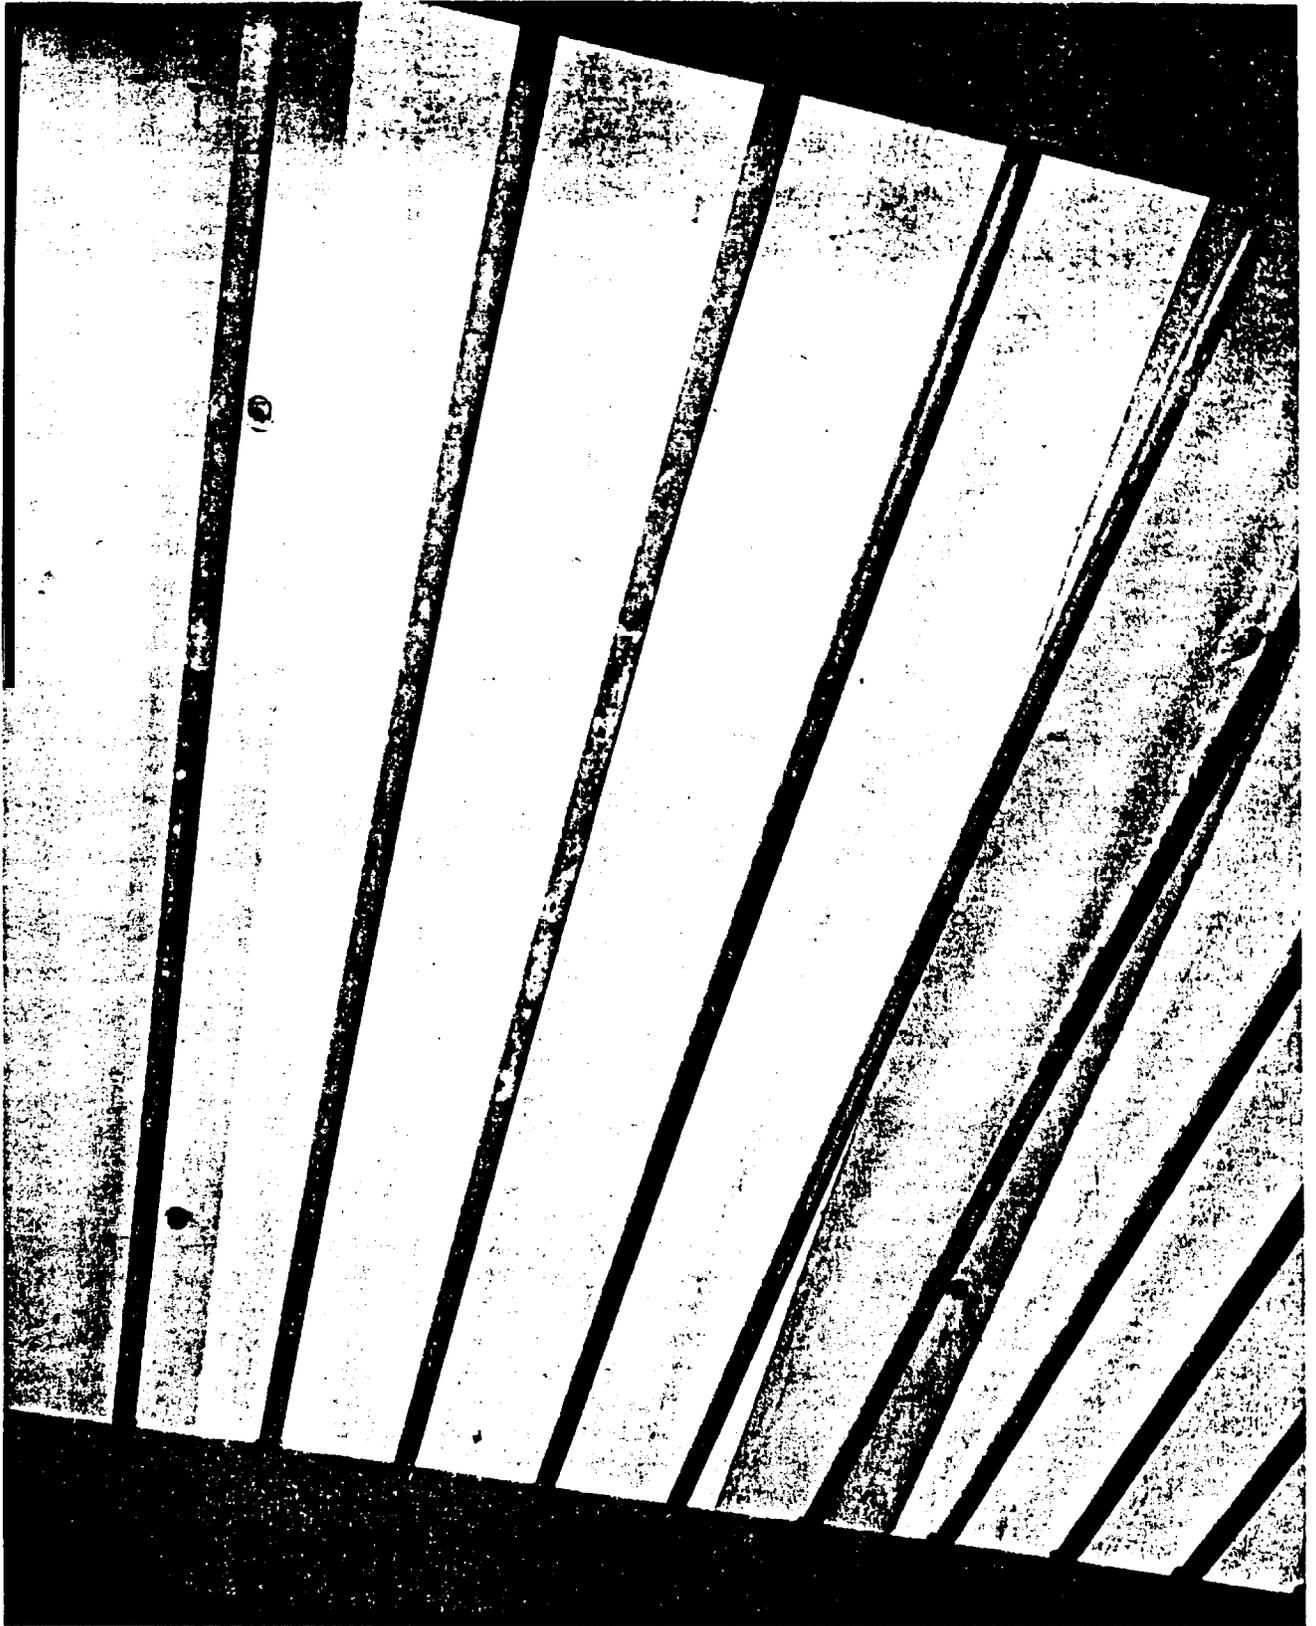
Figures 7 and 8 show other bare and organic-zinc coated tubes in the exposed and sheltered sections, respectively, of Rack Number 3 after approximately 30 months exposure. The coating was applied to "new" tubing samples that had been cleaned with the phosphoric acid wash. These samples, including intentional bare areas (or tape wrapped areas), near the end caps, have remained essentially free of corrosion during this exposure period.

Figure 7. Bare and Organic-Zinc Coated Samples in Exposed Section of Rack Number 3 (After Approximately 30-Months Exposure)

Figure 8. Bare and Organic-Zinc Coated Samples in Sheltered Section of Rack Number 3 (After Approximately 30-Months Exposure)

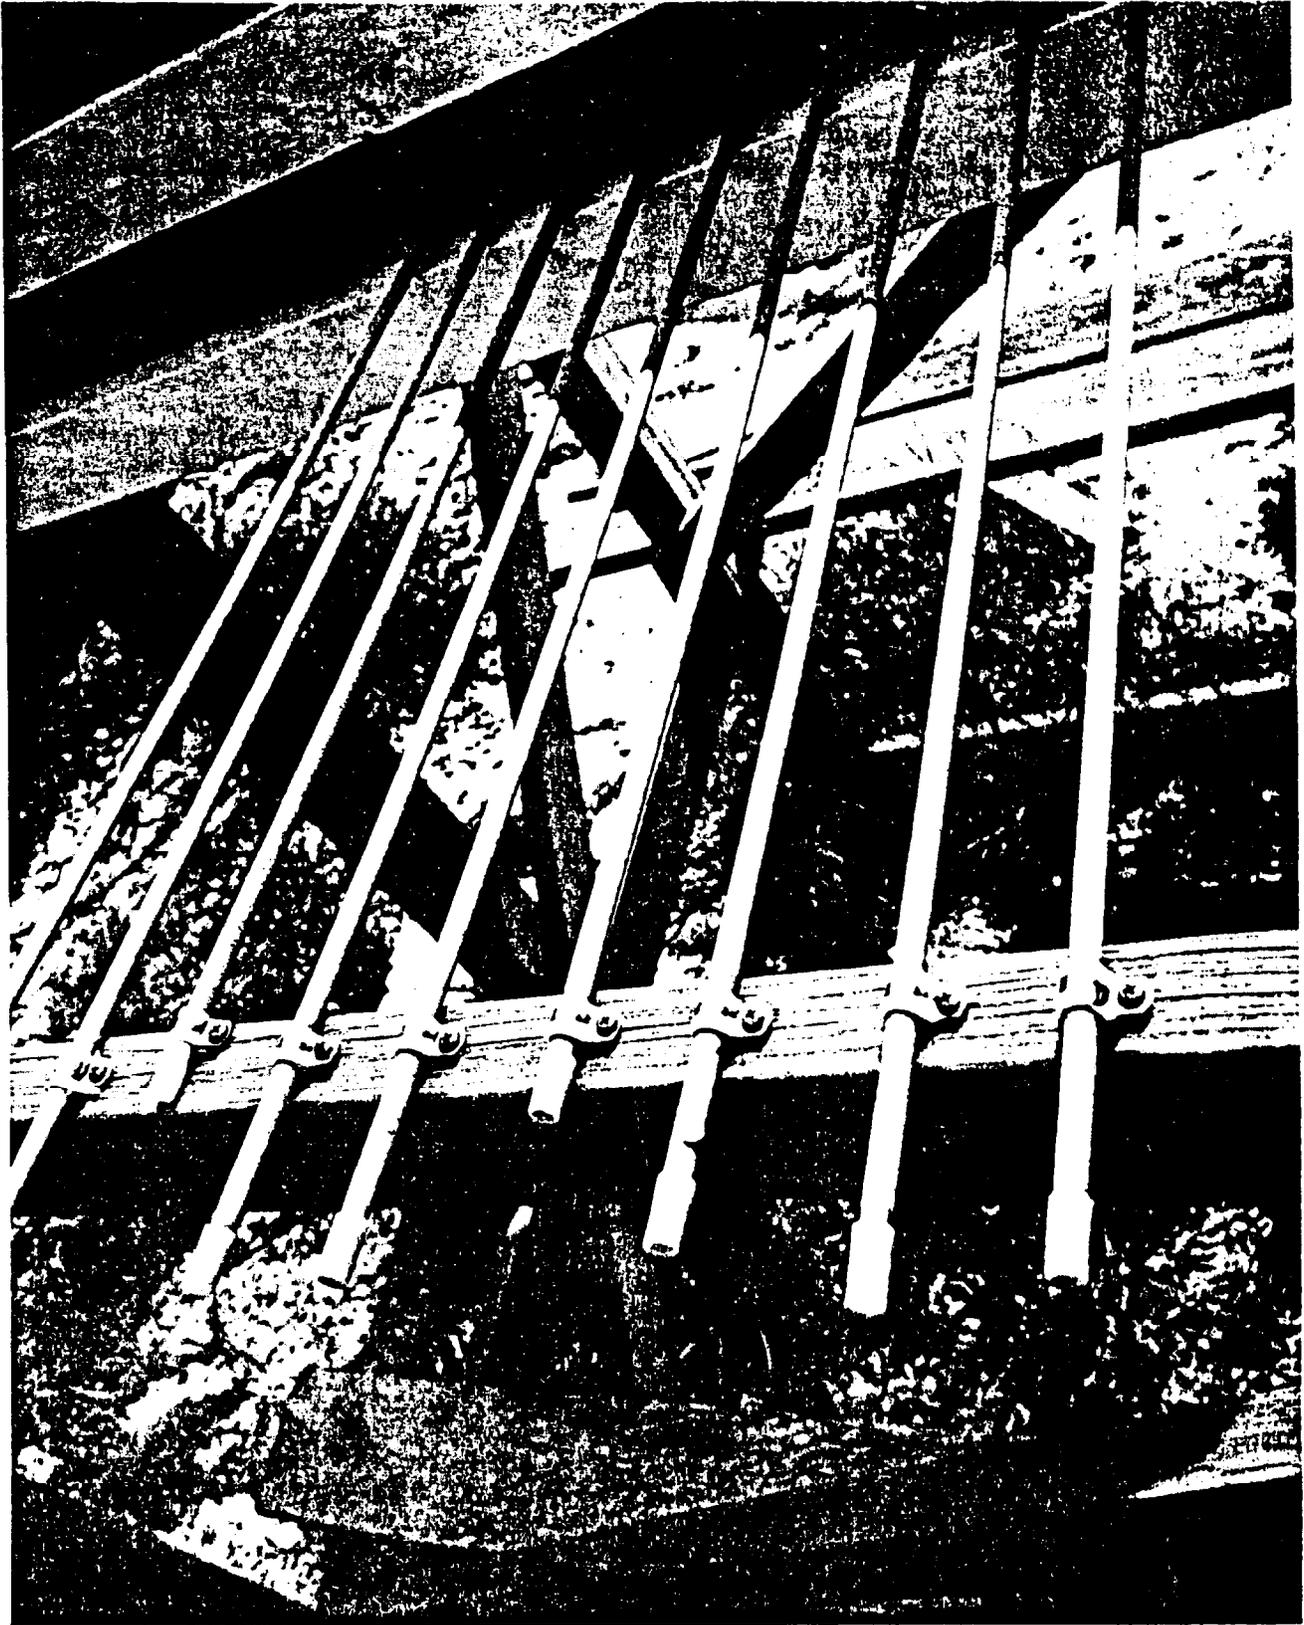
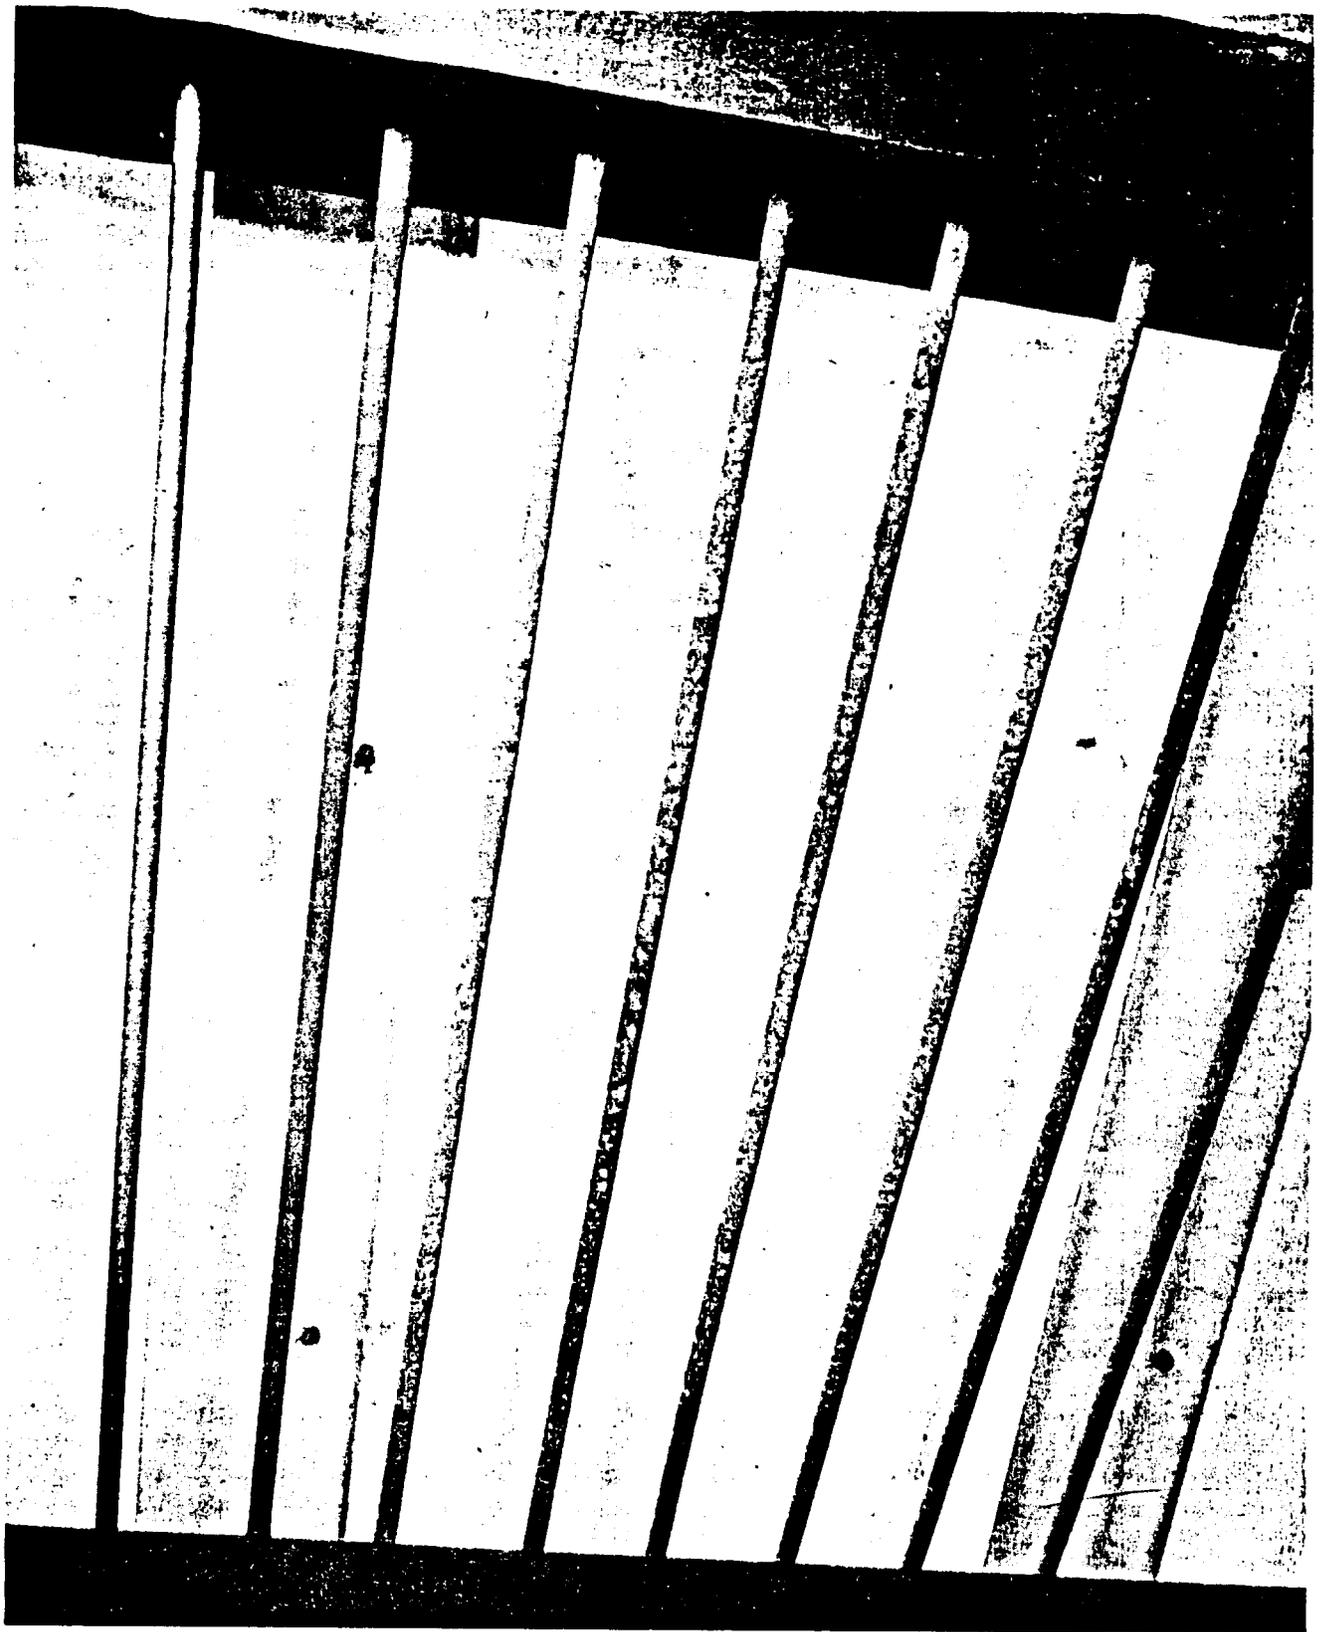
These coatings have remained entirely intact and protective to the stainless steel substrate during the 10 months of exposure. Slight flaking of the organic zinc paint has occurred on the sheltered side of two of the samples, at the X-shaped scribe marks in the coatings. However, the organic zinc coating has continued to protect the substrate in these areas.

Figure 9. Coated Samples in Exposed Section of Rack Number 4 After 10-Months Exposure (2 Aluminum Filled Coatings & 1 Aluminum-Zinc Filled Coating, on Left; Remaining 6 Samples Organic Zinc Paint Coated)

Figure 10. Coated Samples in Sheltered Section of Rack Number 4 After 10-Months Exposure (1 Aluminum Filled Coating & 1 Aluminum-Zinc Filled Coating on Left; Remaining 6 Samples Organic Zinc Paint Coated)

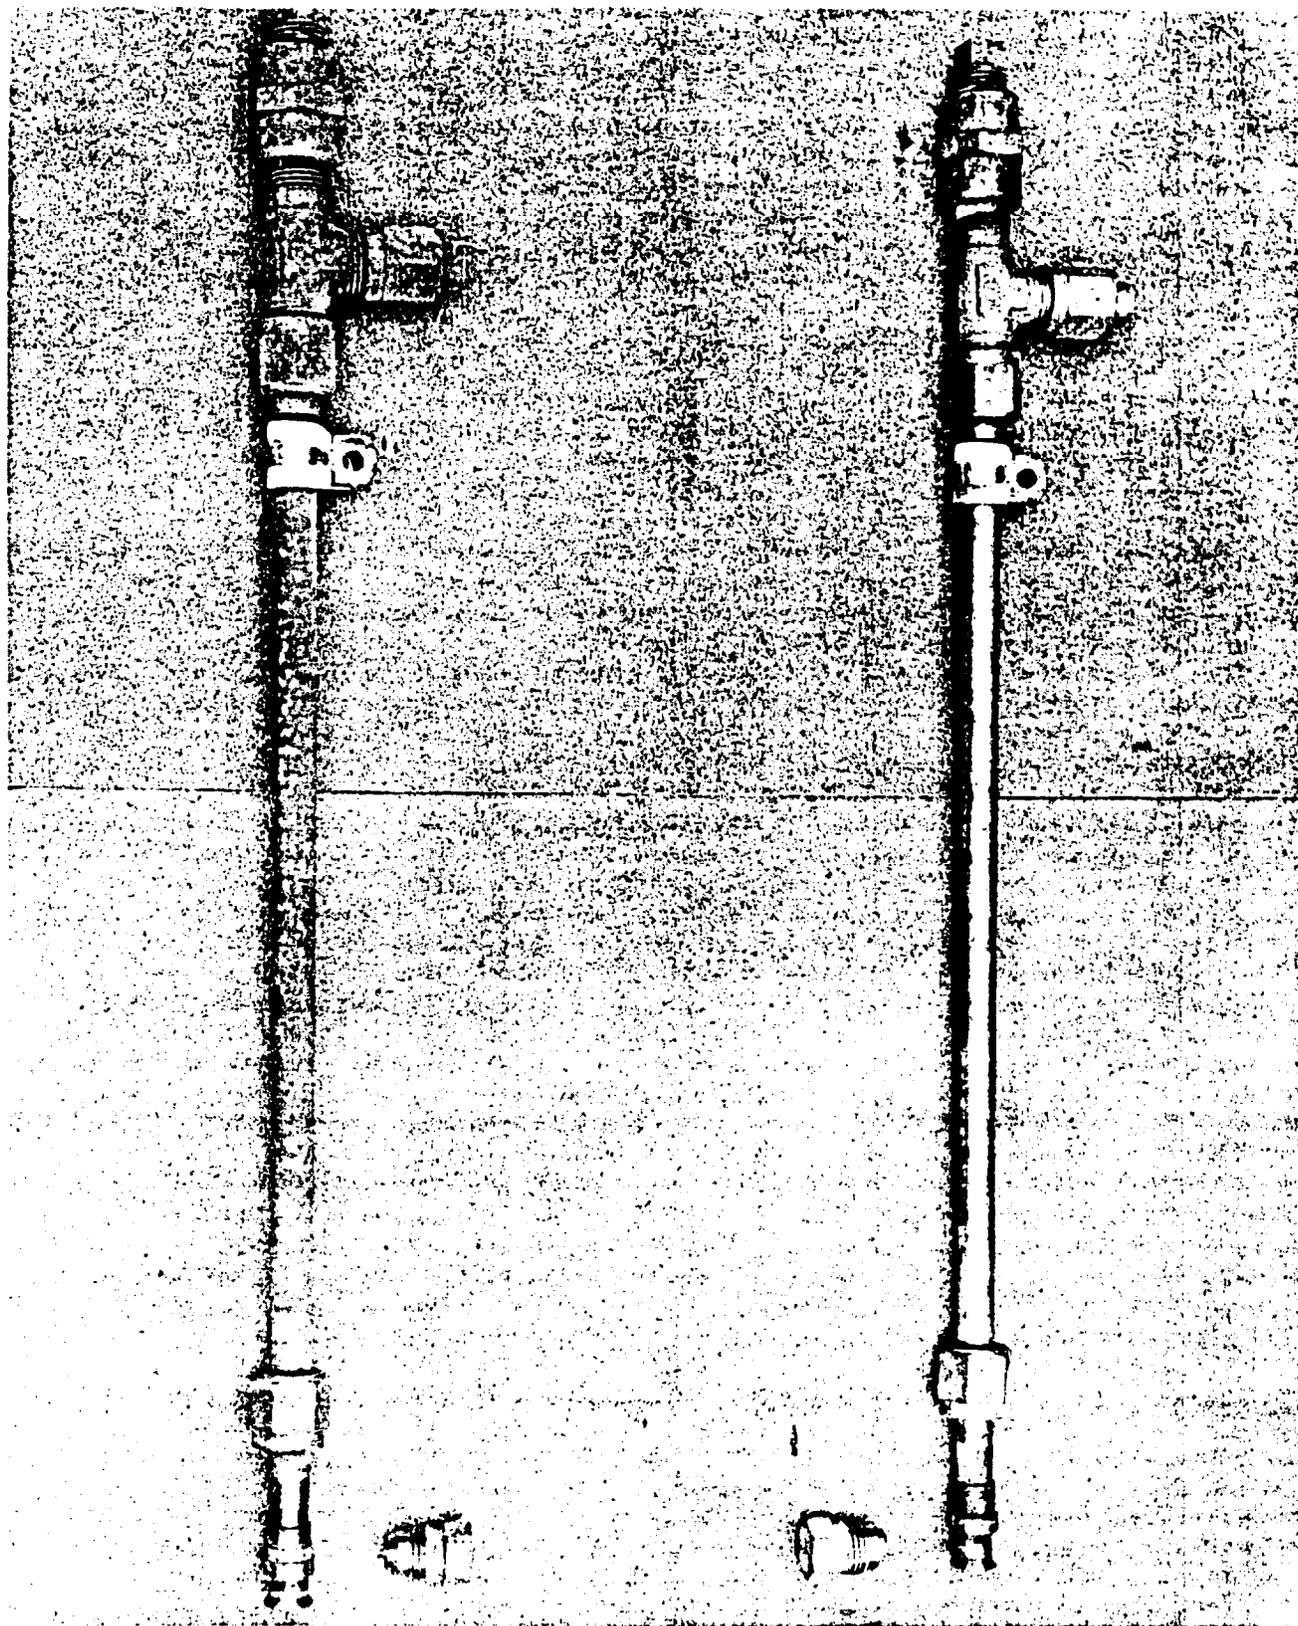
Figure 11 shows two tubing assemblies removed from the sheltered section of Rack Number 4. The sample on the left side has been sandblasted and coated with inorganic zinc paint, and was exposed at the corrosion test site for 12 months. The bare sample was exposed for 14 months. The B-nuts and end plugs were removed, exposing the flared ends of both samples. The zinc coated sample showed no evidence of corrosion. The bare sample had undergone considerable crevice corrosion in the B-nut area, and there were large corrosion deposits under both the B-nut and sleeve. Several longitudinal cracks were noted in the sleeve. The extent of the stress-corrosion cracking, in this B-nut sleeve is described in more detail in subsequent paragraphs herein. It is evident that the zinc coating affords protection against crevice corrosion and stress-corrosion cracking in the area of tubing attachments.

Figure 11. Coated & Bare Tubing Assemblies After 12 and 14 Months Exposure ,
Respectively, in the Sheltered Section of Rack Number 4
(Inorganic Zinc-Rich Paint Applied Over Sandblasted Surface)
